**APT PEST AND
BUILDING INSPECTIONS**

Pre Purchase/Regular Visual Timber Pest Inspection & Report AS 4349.3

Pre-purchase Residential Buildings Inspection and Report AS 4349.1

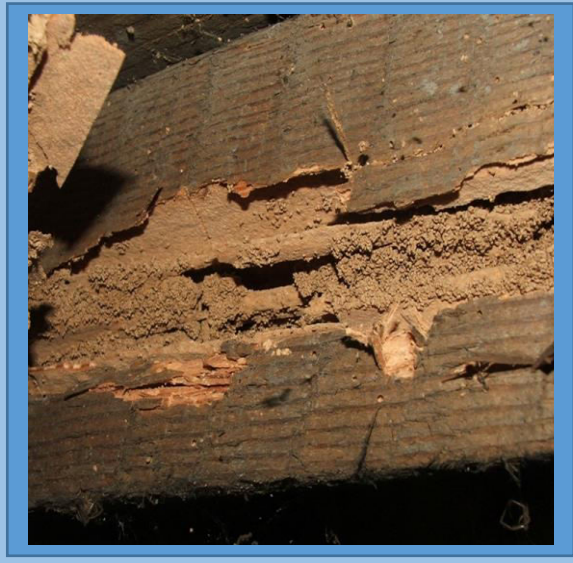
Evidence/Damage No. 1

Information: Timbers damaged by termite, live termite

Activity were found with mud trails. Organize timber

pest treatment expert to treat termite and appoint

a builder to determine damage level and to replace

damaged timbers.

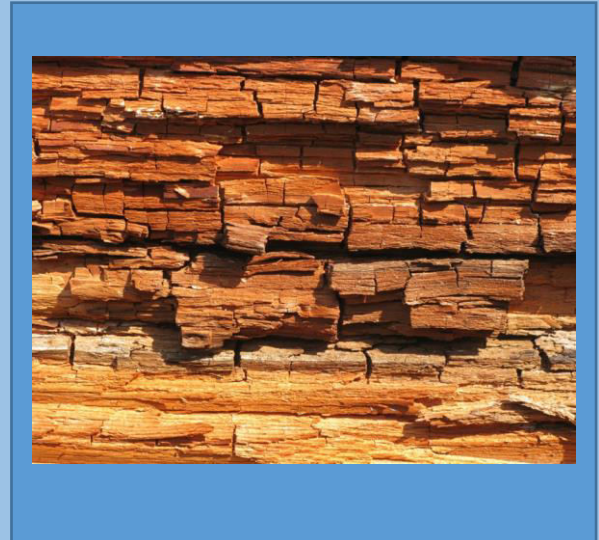
Evidence/Damage No.2

Location: Roof Cavity of Garage

Findings: A roof truss found affected by fungi,
appoint builder to find out water leakage/damage
on roof and to replace damaged timber.

- Organise Builder to identify and fixed water leakage from the roof.
- Other

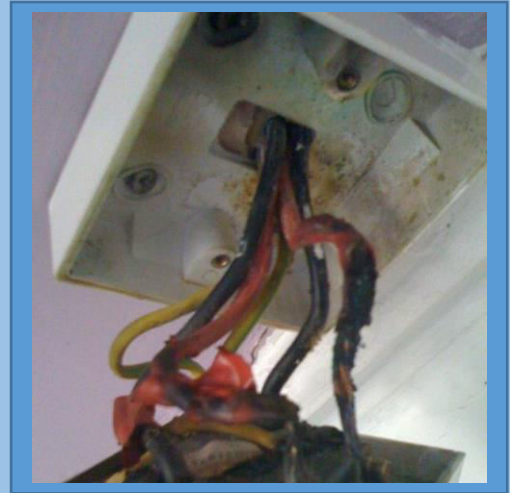
Hazard No. 1

Finding: Broken Switch Board

Information: Broken Switch boards with loose wiring hanging on bathroom 1 wall, high risk of electrical shock, organize professional electrician to fix the problem.

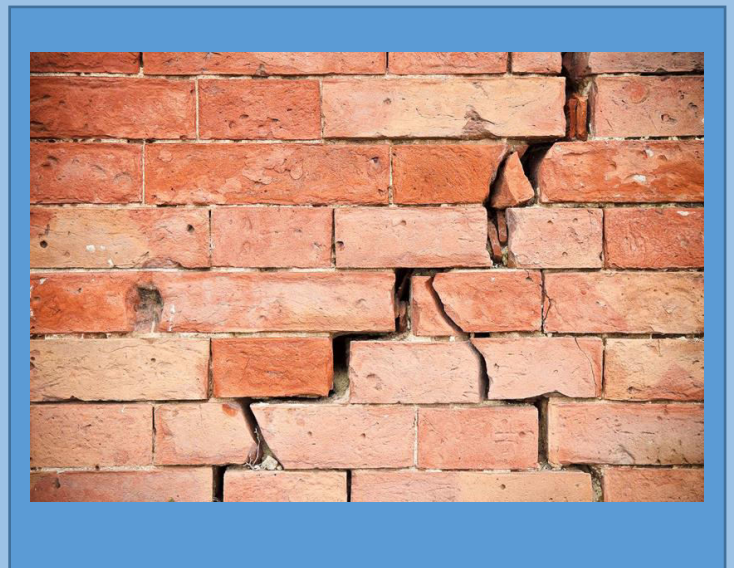
Defect No. 1

Finding: Cracked Brick Walls

Information: Cracked bricked wall found in external wall of the main building from roof to ground in different directions. Appoint experienced builders to rectify the problem.

Appoint builders to rectify and fix defects no. 1, 2, 3 & 4

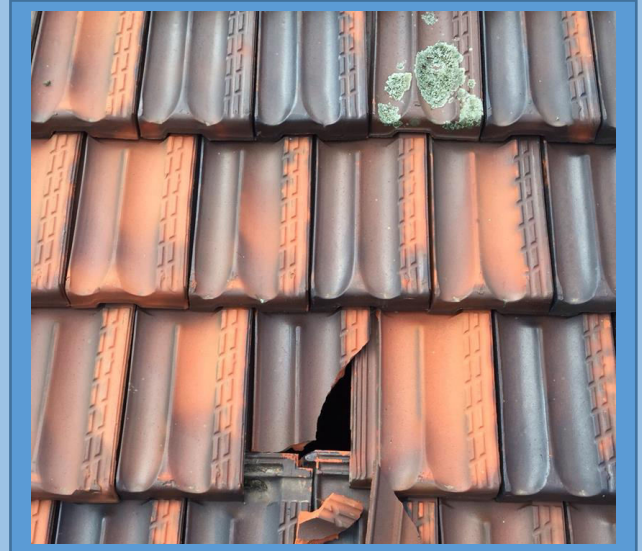
Defect No. 2

Finding: Tiles Cracked on Roof

Information: Cracked tiles found roof. Appoint experienced builders to rectify the problem.

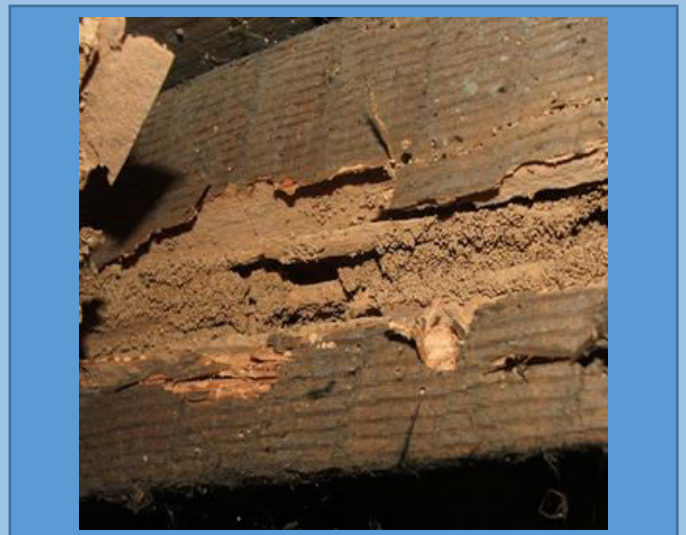
DEFECT NO. 3

See details on Timber Pests Section
(Termite Damage)

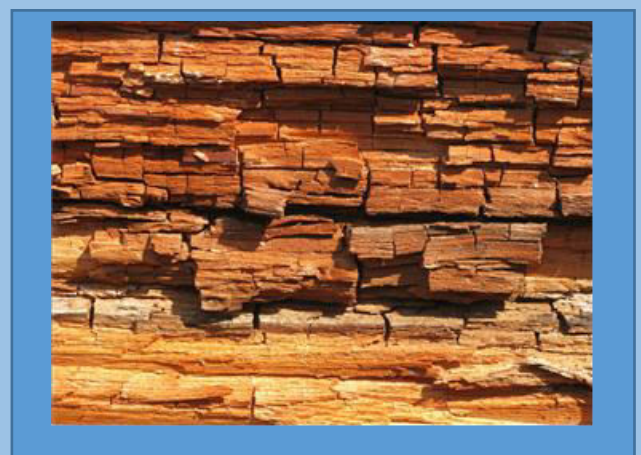
Defect No. 4

See detailed on timber pests section
(Wood Decay Damaged)

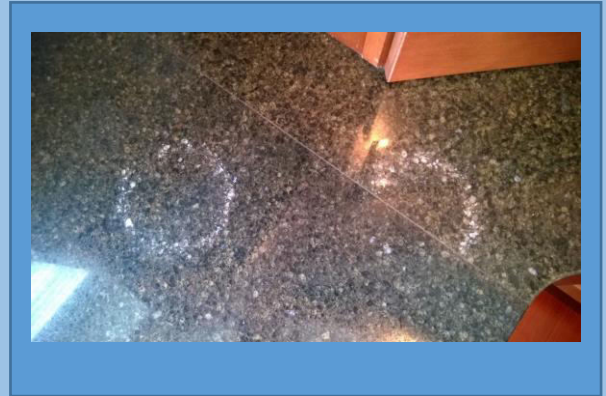
Finding: Tiles Cracked on Roof

Information: 2x Light marks on kitchen slabs.

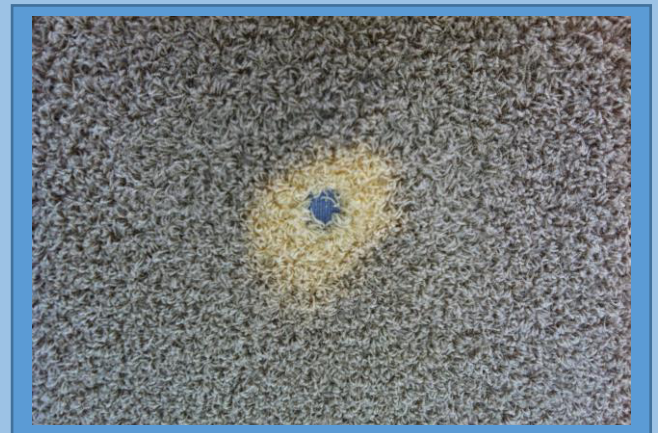
Finding No.2

Location: Lounge Room

Finding: Stains on carpet
